# Manhole Inspection Summary

Manhole # S53G\_\_017MH

Insp Date: **4/15/08 1:27 PM**

**Location** Address: **264 gough St**

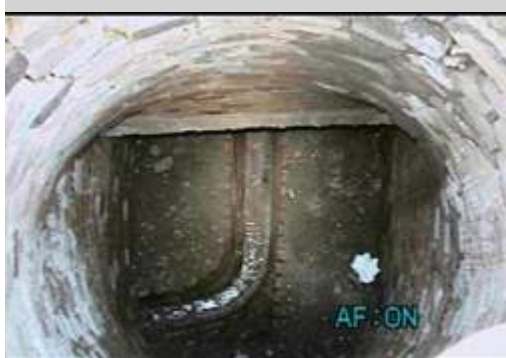
Defect 1

Condition: ☐ Sound ☒ **Cracked** ☐ Root Intrusion ☒ **Loose Brick** ☐ Deteriorated

Infiltration: ☐ None ☒ **Joint** ☐ Cracks ☒ **Mortar** ☐ Roots ☐ Wall

corbel cracked & loose bricks, infiltration

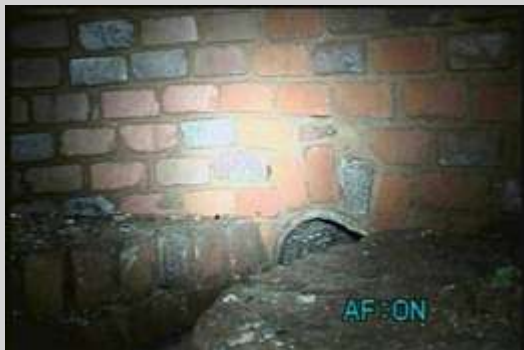
12 O'Clock Outflow

pipe is under shelf
